Docket No. 424 – Development and Management Plan Inspection

The Connecticut Light and Power Company Certificate of Environmental Compatibility and Public Need for the Connecticut portion of the Interstate Reliability Project.

IRP Overhead ROW

Date: September 3, 2014

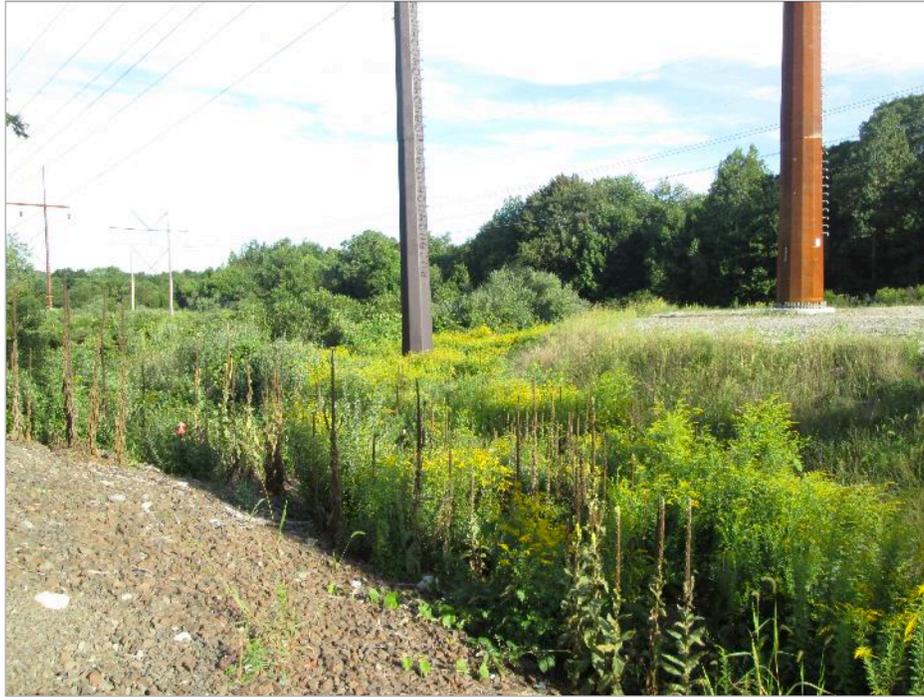
Photo #1: Slope stabilization on northern perimeter of CSSS. (9/3)

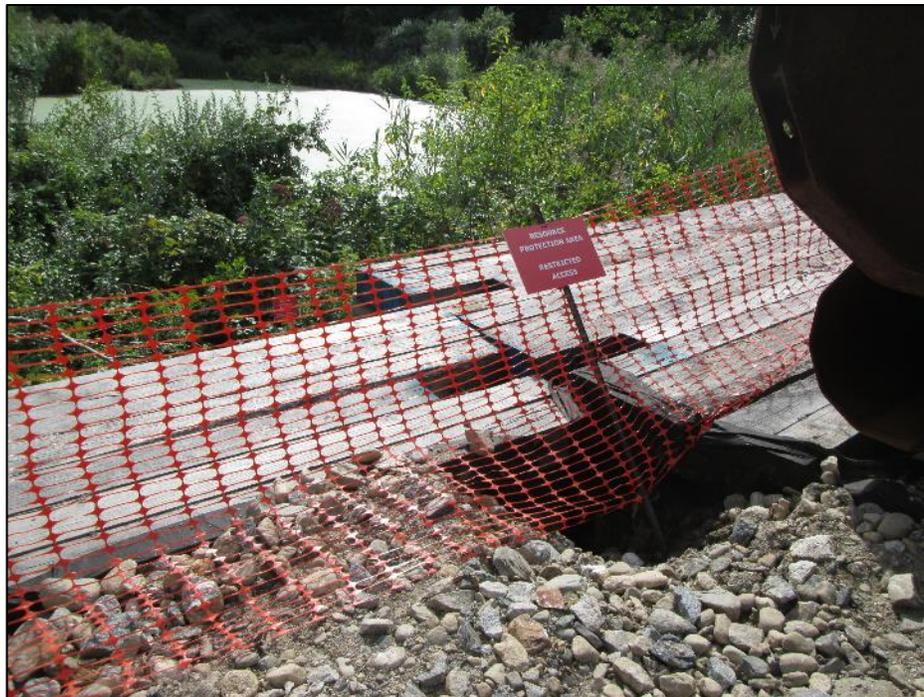
Photo #2: Observed cave-in on edge of wetland mats at Str 49. (9/3)

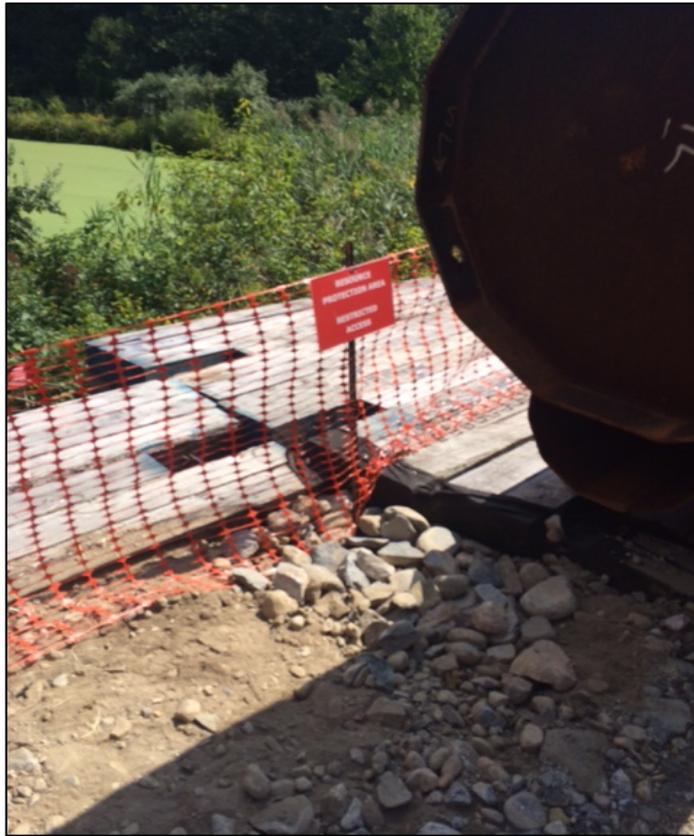
Photo #3: Repaired cave-in on edge of wetland mats at Str 49. (9/3)

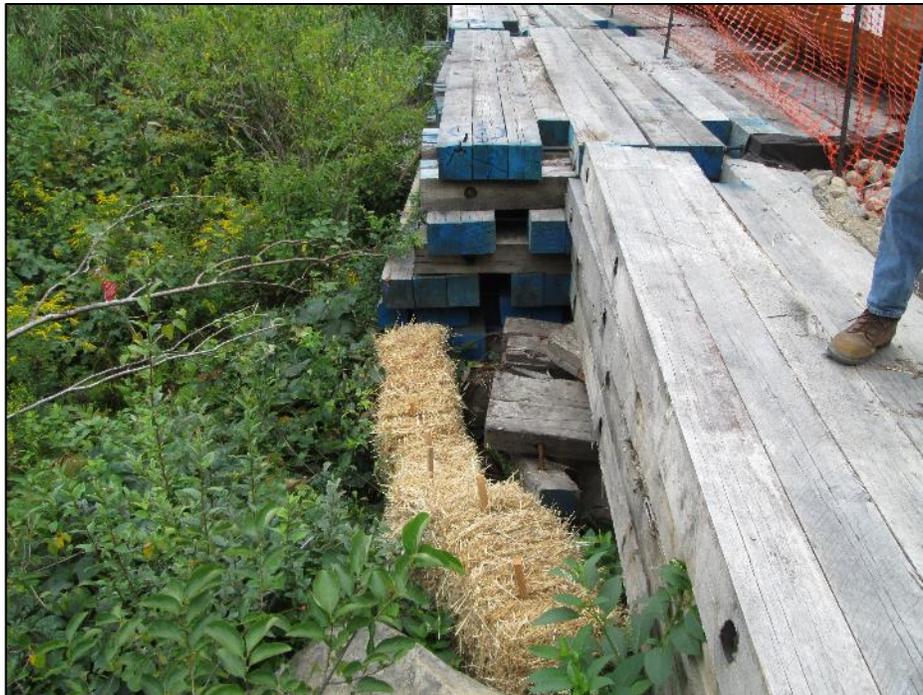
Photo #4: Addition of hay bales to prevent potential future problems at Str 49. (9/3)

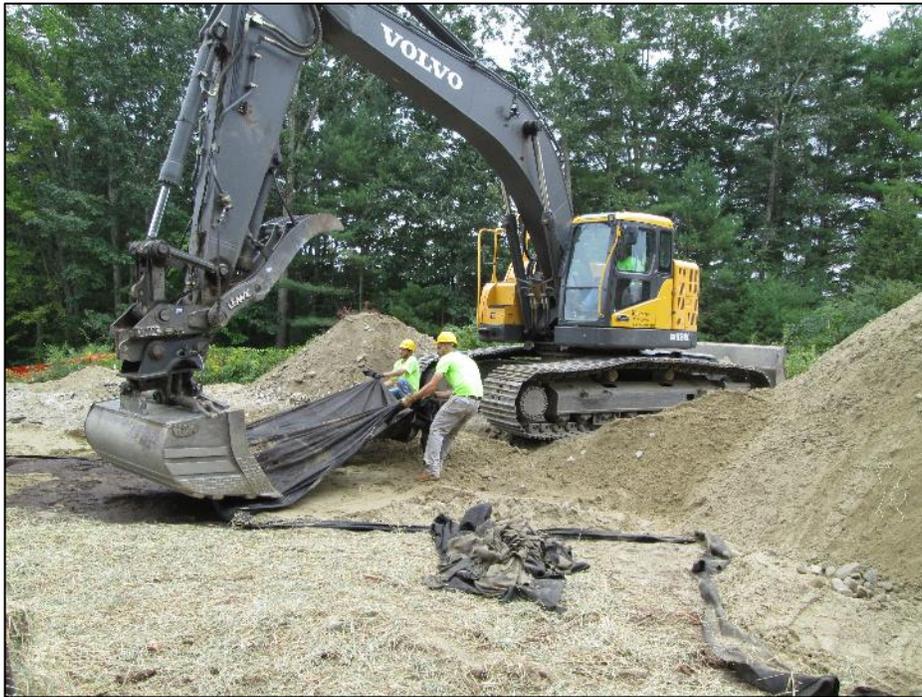
MS17, Str 86: Reclamation and restoration of Str pad 86 and access road, seeding and spreading of hay on exposed soil. (Photo 4 & 5)

Photo #5: Removal of construction pad, geotextile fabric, and sand buffer layer at Str 86.

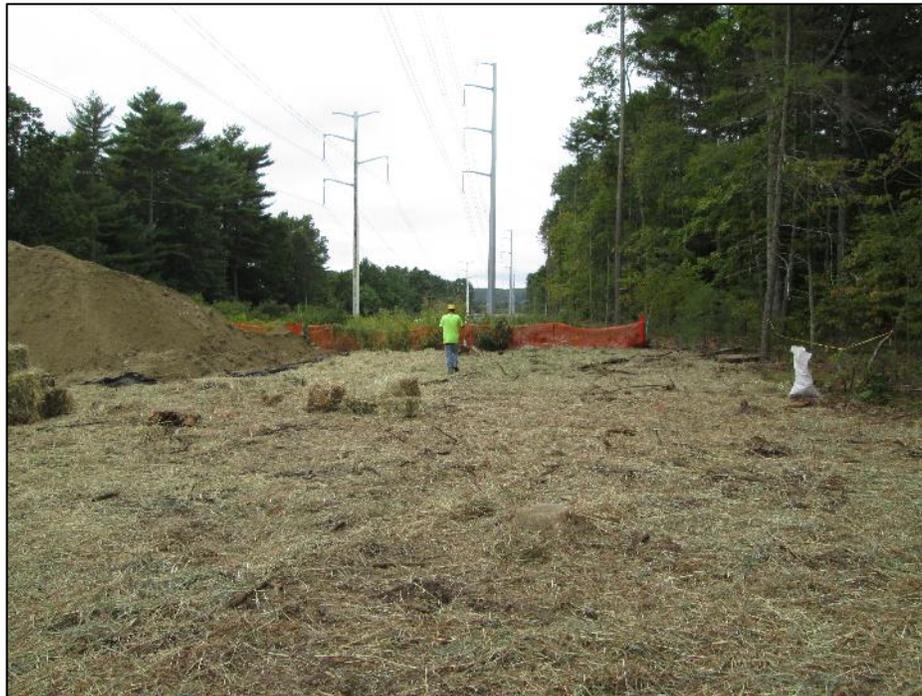
Str 63: Child pool under machinery for precautionary measures at Str 63. (Photo 11)	Continue to follow this procedure.	NA
		Str 86: spreading of hay and seeding on exposed topsoil. (Photo 6)	Continue to follow this procedure.	NA
Erosion and Sedimentation Controls	Bi-Week (9/10)	Str 147: Additional straw bale reinforcement and stone berm installed to support silt fence up-slope of wetland area.	Continue to follow this procedure.	NA
Inland Wetland and Watercourse encroachment and mitigation	Interim Week (9/3)	Mat installations in wetland areas are in accordance with the BMP Manual.	Continue to follow this procedure.	NA

Photo #6: Spreading of hay and seed on restored Str pad 86.

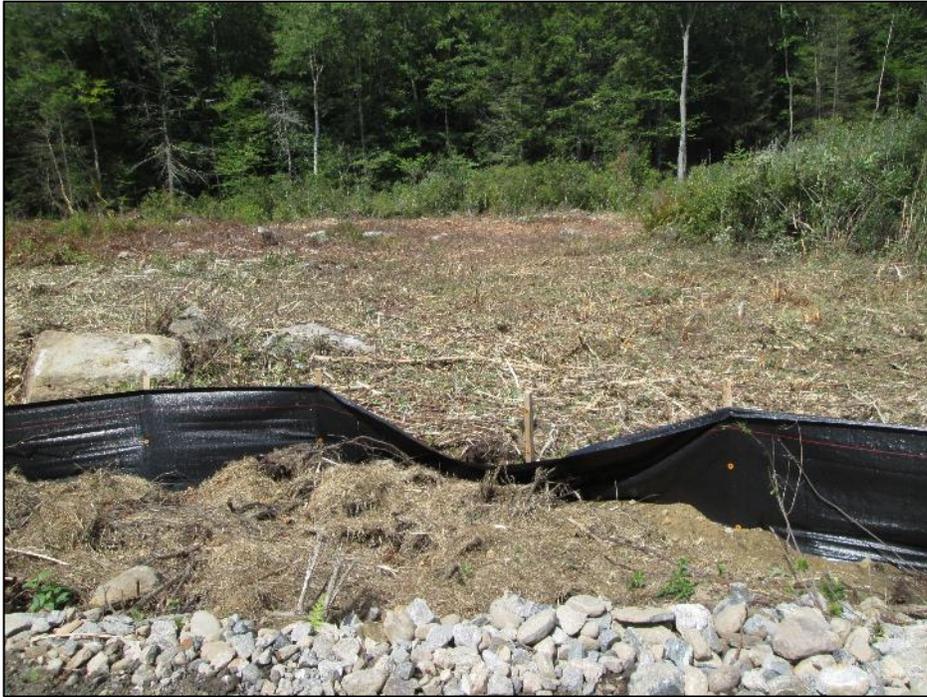
Photo #7: Damaged silt fence up-line of Str 164. (9/3)

Bi-Week (9/10)	All crossings appear to be functioning in accordance with the BMP Manual. No sediment appears to be entering the streams or wetlands.	Continue to follow this procedure.	NA
Erosion and Sedimentation Controls	Interim Week (9/3)	Noted that stockpile areas along ROW are being surrounded with straw wattles and stabilized with blown straw.	Continue to follow this procedure.	NA
		Str 49: Observed two (2) pad-stone cave-ins and a separation between filter fabric layers on edge of wetland mats. There was no observed discharge into wetland. (Photo 2, 3 & 4)	NA	Northern crew repaired separated fabrics, cave-ins areas with new stone and added straw bales on the down-gradient pad edge for additional protection. (Photo 2, 3 & 4)
		Str 64: Child pool under machinery for precautionary measures at Str 64.	Continue to follow this procedure.	NA
Erosion and Sedimentation Controls	Bi-Week (9/10)	Str 164: Observed damaged silt fence up-line of Str 164. (Photo 7 & 8)	NA	Northern crew immediately repaired damaged silt fence.

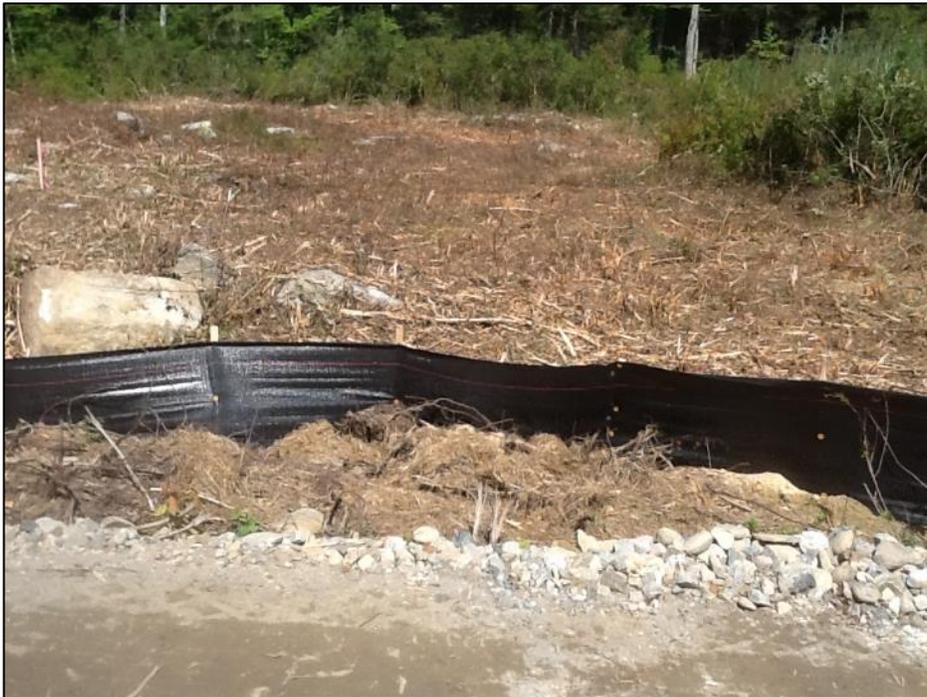
Photo #8: Repaired silt fence up-line of Str 164. (9/3)

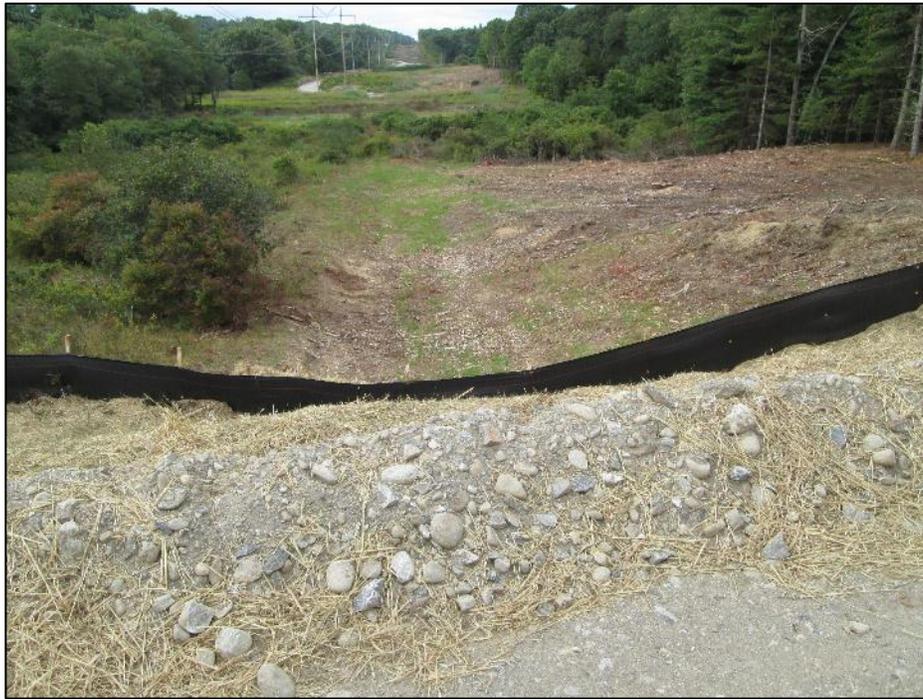
Photo #9: Addition of stone berm for added erosion control measures at Str 147.

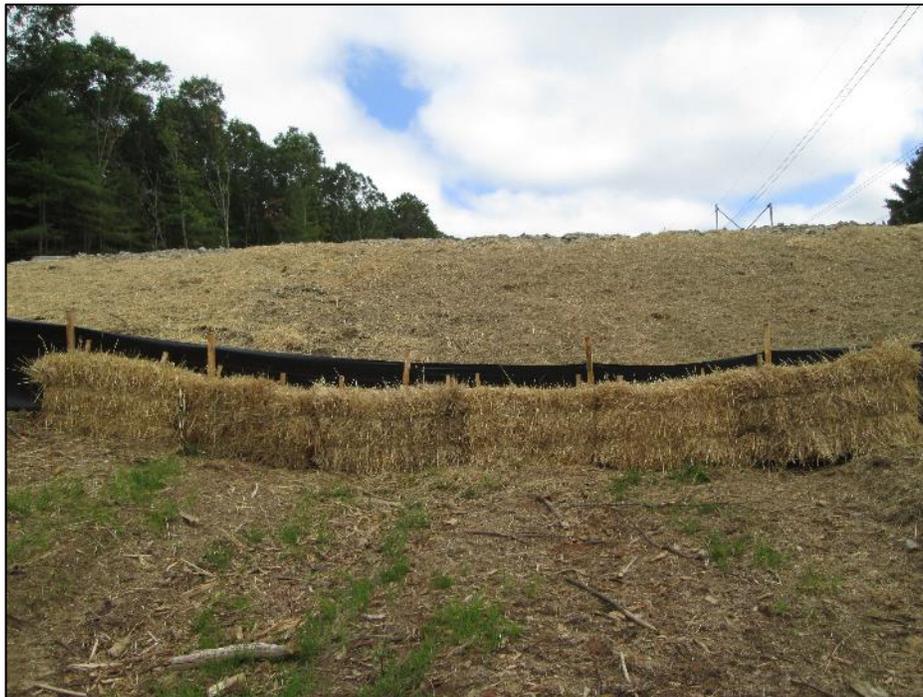
Photo #10: Addition of hay bales to reinforce silt fence and hay spread on slope for stabilization at Str 147.

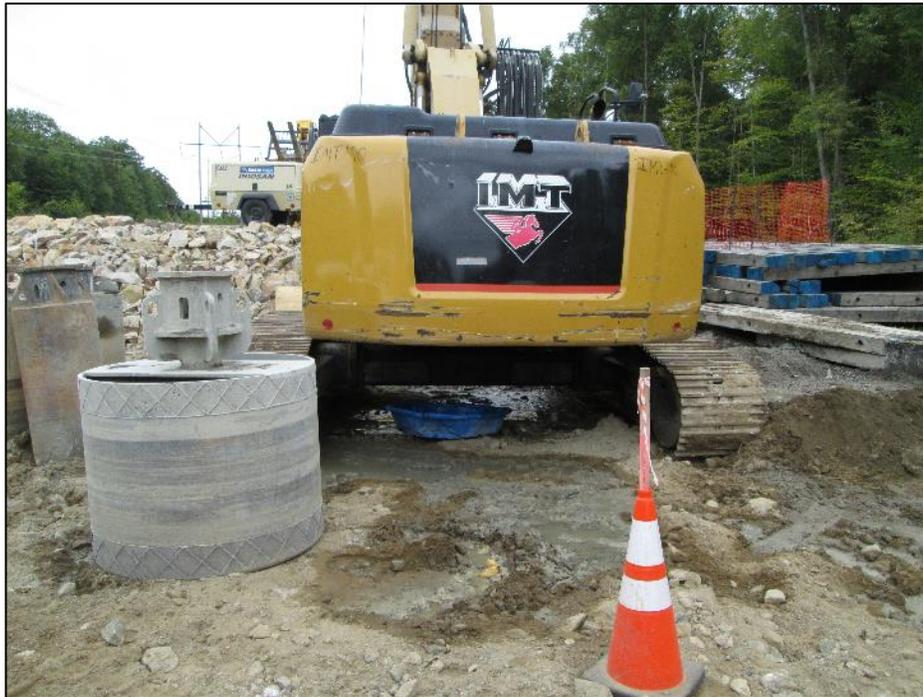
Photo #11: Child pool under drilling machinery for precautionary measures at Str 63.

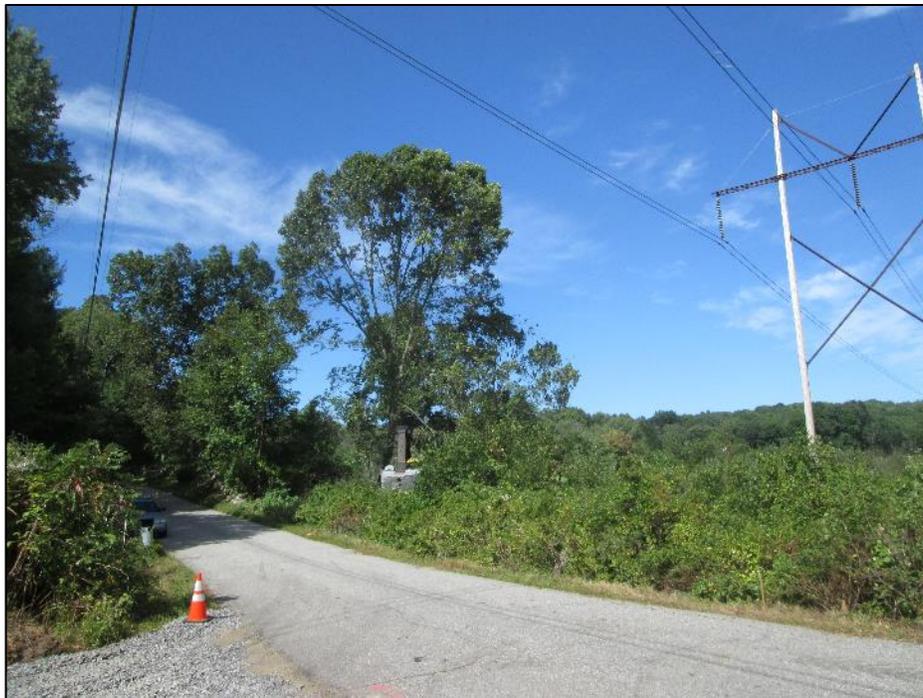
Photo #12: Tree clearing with feller/buncher at Str 187. (9/3)
